Assessment of stability problems at southern engineered slopes along Mersin-Tarsus Motorway in Turkey

Hidayet Taga · Sedat Turkmen · Nagehan Kacka

Abstract This paper describes the cut slope stability problems of southern engineered slopes along 57 km long Mersin-Tarsus Motorway. While the northern slopes were slipping during and following construction, the stability problems occurred at southern slopes after heavy rains in December 2001. The most recent slope stability problem took place on chainage at the km 10+800 embankment on 9 April 2009. About 3.62×10^6 m³ soil materials have currently slipped at 60 different location. After the occurrence of slides, different remedial methods (reshaping slopes, soil improvements, etc.) have been applied to stabilize the slipped slopes. The slope stability studies were carried out using back analysis to determine the slope failure mechanisms and to estimate effective shear strength parameters. Pore water pressures increase following intense rainfall events and cause reduced resistance to shear strength at the engineered slopes. In addition, the affects of the static and dynamic parameters to analyse the state of the slope after excavation

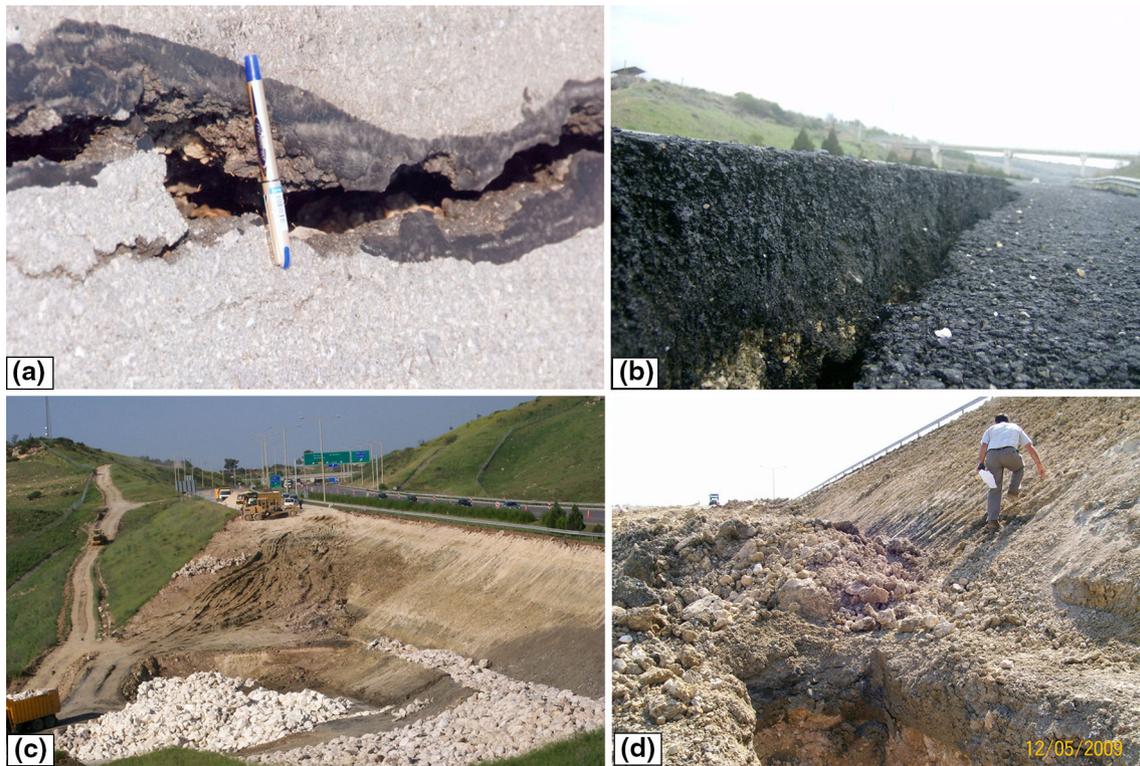
Fig. 9 Tension cracks in the pavement before failure (a), a picture of straight scarp on embankment slide (b), general view from embankment failure at chainage km 10+800 (c) and a close-up view of a failure surface (d)

Earth material extracted from excavation slope at chainages km 12+250 were used as filling material at chainages km 10+800. Based on the observations during excavation works, it was clearly understood that required compression conditions had not been applied during filling.

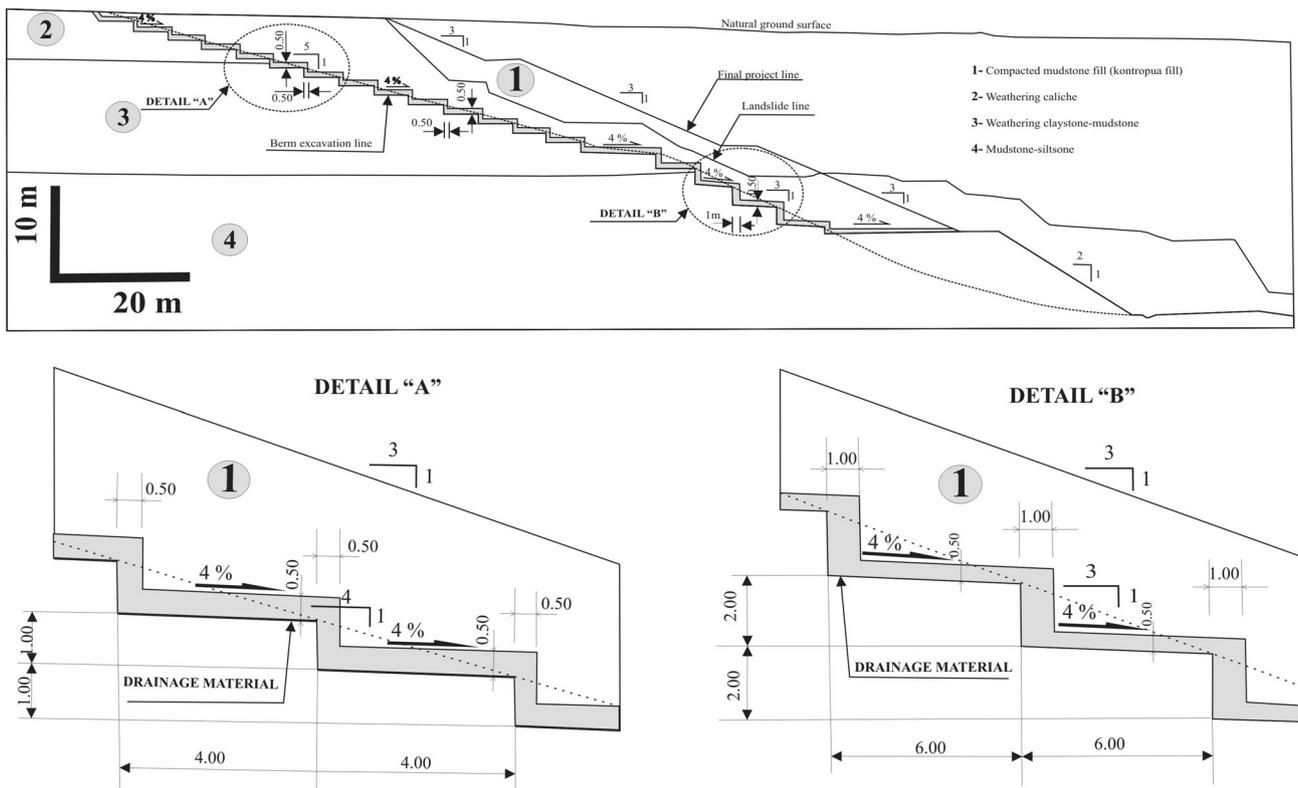
The same cut slope design was applied in the 57 km long motorway without considering local soil and geo-technical properties (Fig. 10).

Fig. 10 Detail of identical project on cut slopes along the motorway during construction

Identical projects were applied in the 57 km motorway without considering local geological and geotechnical attributes in cut and embankment slopes. By the performed limit equilibrium analyses, it was determined that the slopes are stable under static and dry conditions, but they lose their stability under dynamic and saturated conditions.

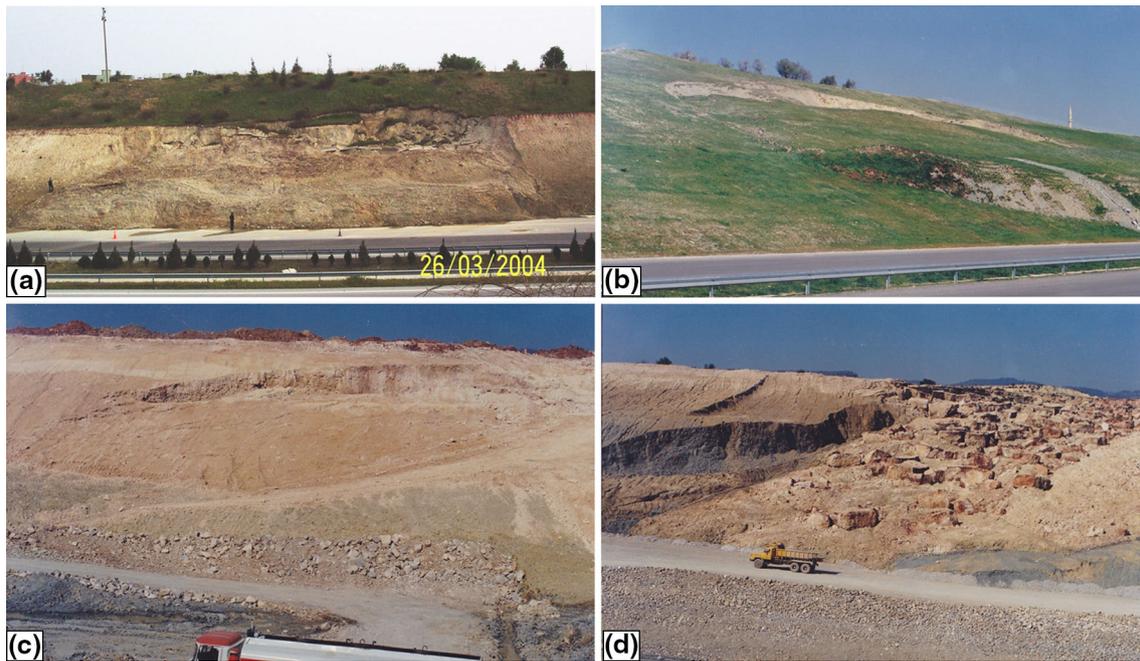
varying between 10 and 15 m. The movement generally started in the middle parts of the slopes and propagated towards the road platform, and the failed material was carried to the pavement. Then, the landslide continued progressively by reaching the upper level (Fig. 11a).

Several factors have been played a slippery role in the MTM. These factors are described as directions of general discontinuities, south directions of topographical slopes (Fig. 11c), and extremely thick caliche structure in the region (Fig. 11d). The site investigations uncovered a relatively permeable stratum, a caliche unit, overlying the upper part of the landslide. This unit has lots of horizontal and vertical discontinuities. In general, motorway slopes vary between 24–30 m, and remedial measures taken were not satisfactory although 5 m floats were built at every 10 m (Fig. 11).

Fig. 11 General view from cut slope sliding at chainage km 12+250 (a), rotational failure chainage km 22+320 (b), a close-up view from the northern slope failure (c) and tilted slump blocks in the thick caliche at of the northern slopes that slid (d)

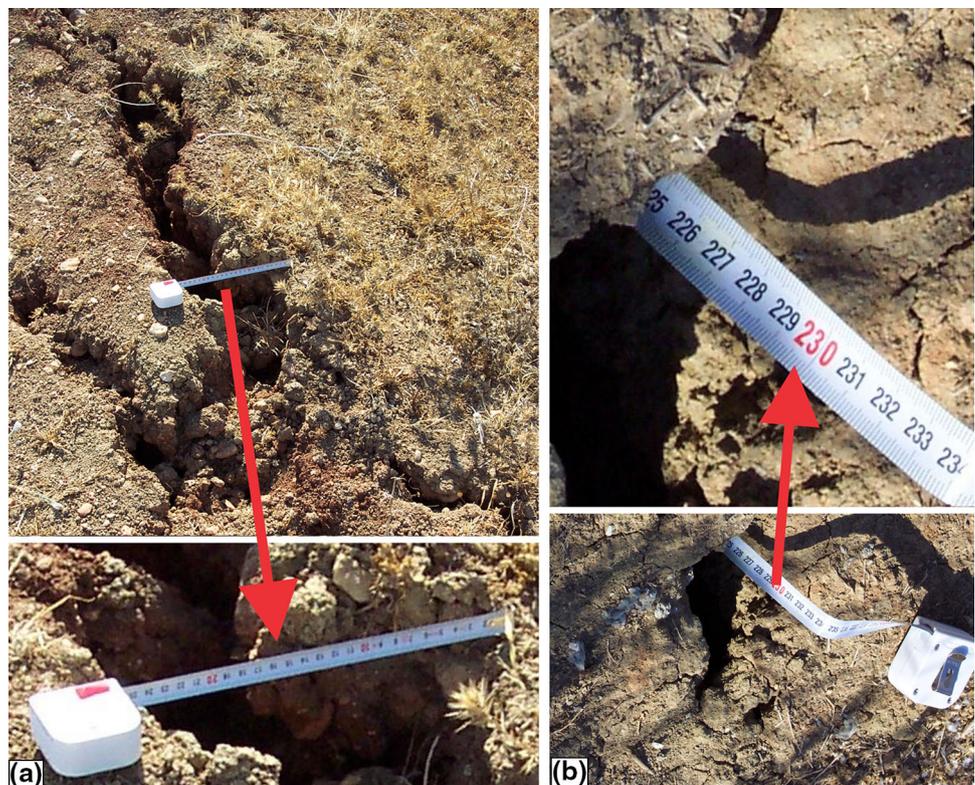
In the slopes that the slips occurred, the type of movement, depth of the mass slipping, and activity situations were determined through field measurements. During the field studies, expansion cracks were observed between 18–49 cm and at a depth of 230 cm at the top parts of slopes (Fig. 12), and they were in bends in trees planted for development purposes and at water leakages in bottom parts. As there is a back-slope in this zone occurring as a circular fall and slips circularly, ground water accumulates in the upper parts and creates a continuously moving, expanding, and spreading structure (slip width 186 m).

Fig. 12 A view from expansion cracks (a) and depth (b) at chainage km 12+250

The following two factors might cause landslides after heavy rainfall: (1) Pore water pressure built up in the nearly vertical joints and fissures of claystone on the slope surface (Fig. 12) and (2) the low friction angle on the weathered claystone. In addition, the caliche unit has a negative effect due to the weight on the slope.

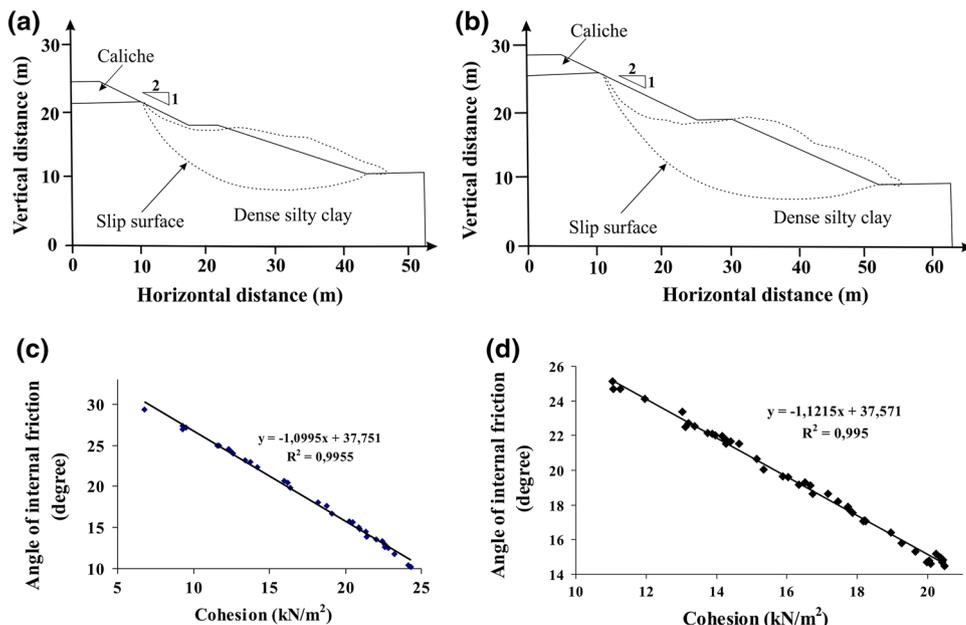
In this study, when back analysis was applied, the soil was considered fully saturated because instability occurred immediately after heavy rains between the 1st and 9th of December 2001. The critical sliding failure surfaces were found to be the ones that connected the crest and toe observed in the site and identified as the primary failure plane in Figs. 11, 13a, c. For the analysis, variations of the residual shear strength parameters (c' and ϕ') of the dense silty clay satisfying a factor of safety (FS) of 1 corresponding to the limit equilibrium condition were determined for different shear strength pairs by using Slide (6.0) software of Rocscience (2012) for the circular slide (Table 2). While the residual shear strengths of the materials were obtained by Slide (6.0), the probabilistic analysis option was used to carry out back analysis of two variables simultaneously (Fig. 13b, d).

Fig. 13 Slide surface and results of two-dimensional back analysis of the sliding block of chainage km 12+250 (a, b) and km 22+320 (c, d)

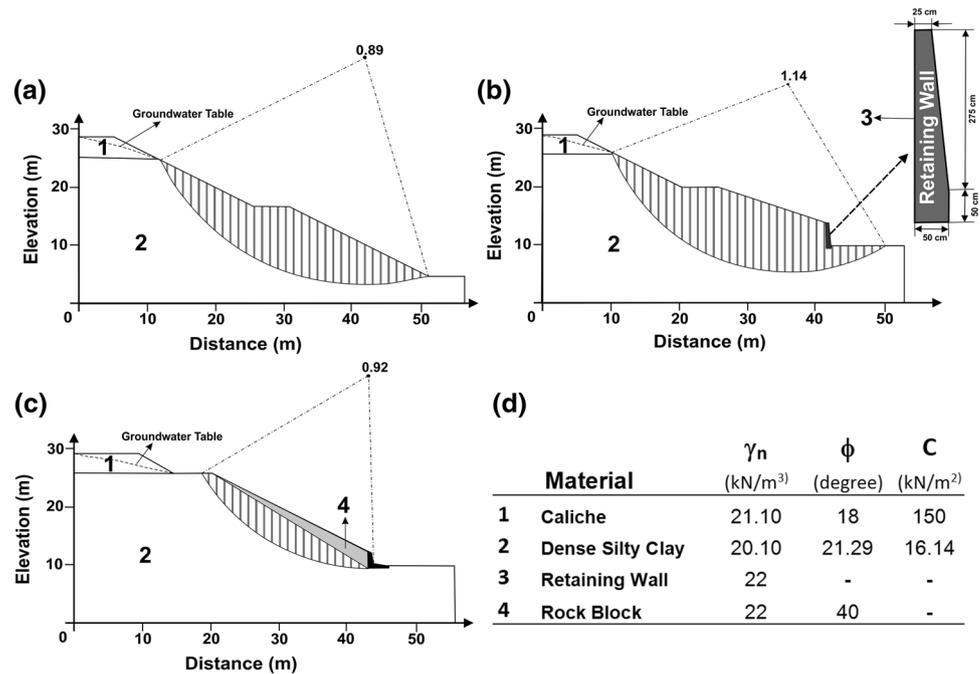
Fig. 14 Remedial slope stability analysis result. **a** Fully saturated and no quake, **b** supporting by putting rock block to the toe, **c** installing retaining wall and **d** used data in stability analysis on chainage km 12+250

Stability analyses performed showed that rock blocks of 0.5–1 m thickness negatively affected stability. Slope stability analyses have been performed for several cases so as to simulate supporting action by putting boulders to the toe and installing a retaining wall under static and dynamic conditions for dry and saturated states (Fig. 14a–d). It is determined that the improvement structures formed by putting rock blocks at the bottom will lose their stability in an earthquake causing horizontal ground acceleration of 0.12 g (Fig. 14b). After the improvement to be made with a retaining wall, it is foreseen that there will not be any failure in slope improvements both in wet and dry conditions (Fig. 14c). The factor of safety of the final slope design of the retaining wall, in static and fully saturated conditions, is 1.35. In seismic conditions, considering a maximum of 60 cm/s^2 horizontal seismic load, the factor of safety decreases to 1.15 (Fig. 14c, d). In this study, partial removal of landslide material, retaining wall, and surface drainage are judged as remedial measures.
