Tensile Strength Alteration of GFRP Composite Pipes Under Seawater-Dominated Conditions

Alper Gunoz · Yusuf Kepir · Memduh Kara

Submitted: 7 February 2020 / Published online: 9 August 2020
© ASM International 2020

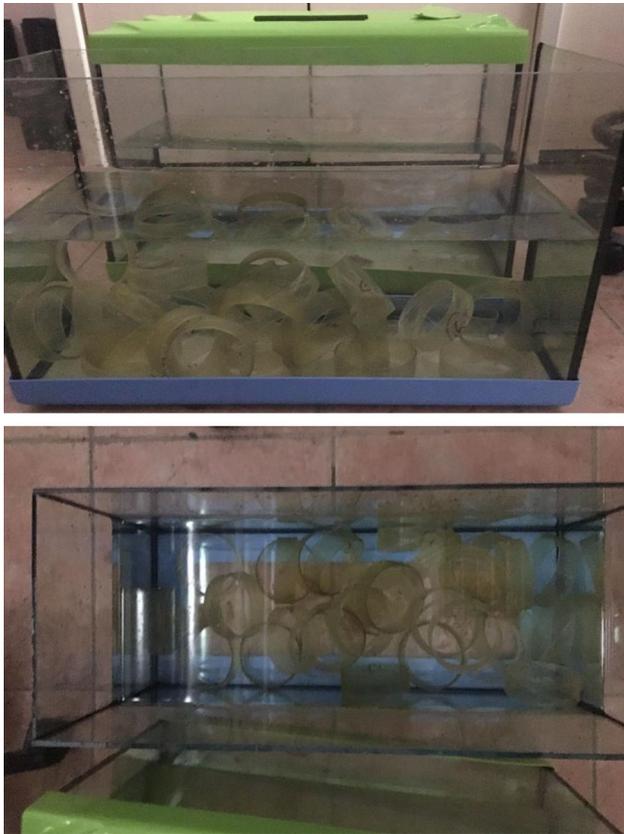
Fig. 2 Samples exposed to seawater aging

Mediterranean water, which has a high salinity (3.8%), has an abrasive effect on the matrix of composite pipes. There are high amounts of NaCl, MgCl, MgSO₄, CaSO₄, K₂SO₄, CaCO₃, MgBr₇ salts in Mediterranean water [30]. The GFRP composite pipes exposed to aging in seawater for 1, 2 and 3 months are shown in Fig. 2.
